The Scottish  
Parliament

**TECHNICAL ANNEX  
LETTER TO FINANCE COMMITTEE, AUGUST 2003**

This technical report has been produced, at the request of the Presiding Officer, to enable those without a detailed knowledge of the Holyrood site to understand the complexities of the lightwell area and their impact upon completion of the project.

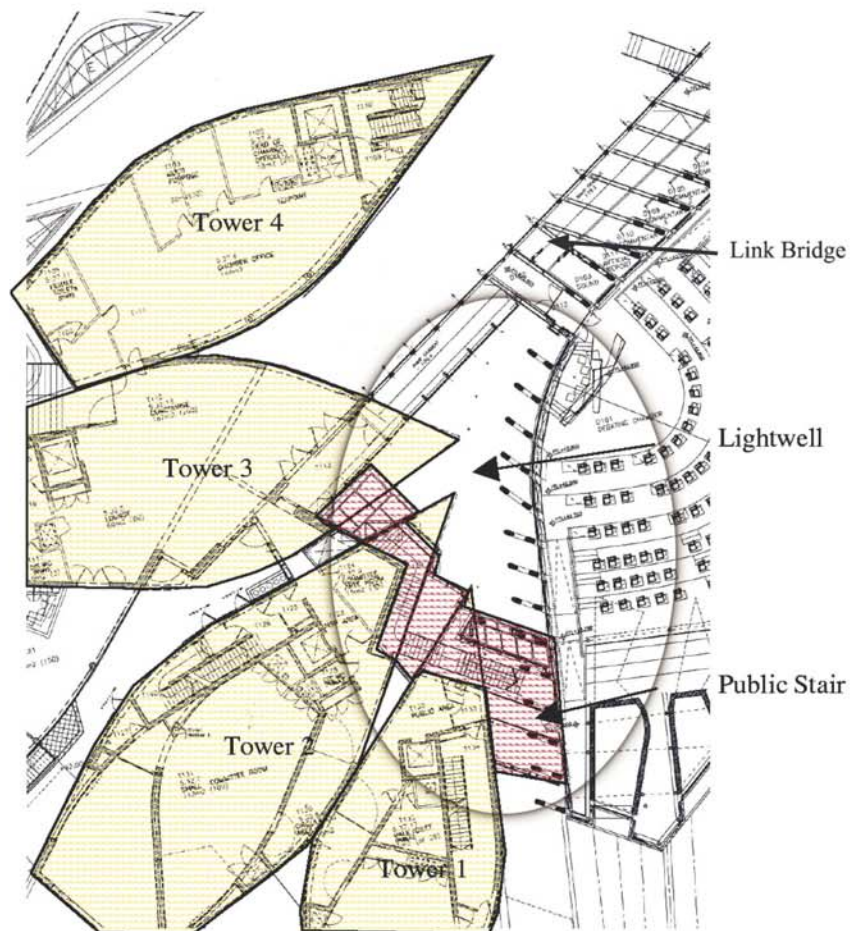
*The Lightwell area: central to the completion of Holyrood, but a highly complex and constrained space in which all activities have to be completed one at a time sequentially.*

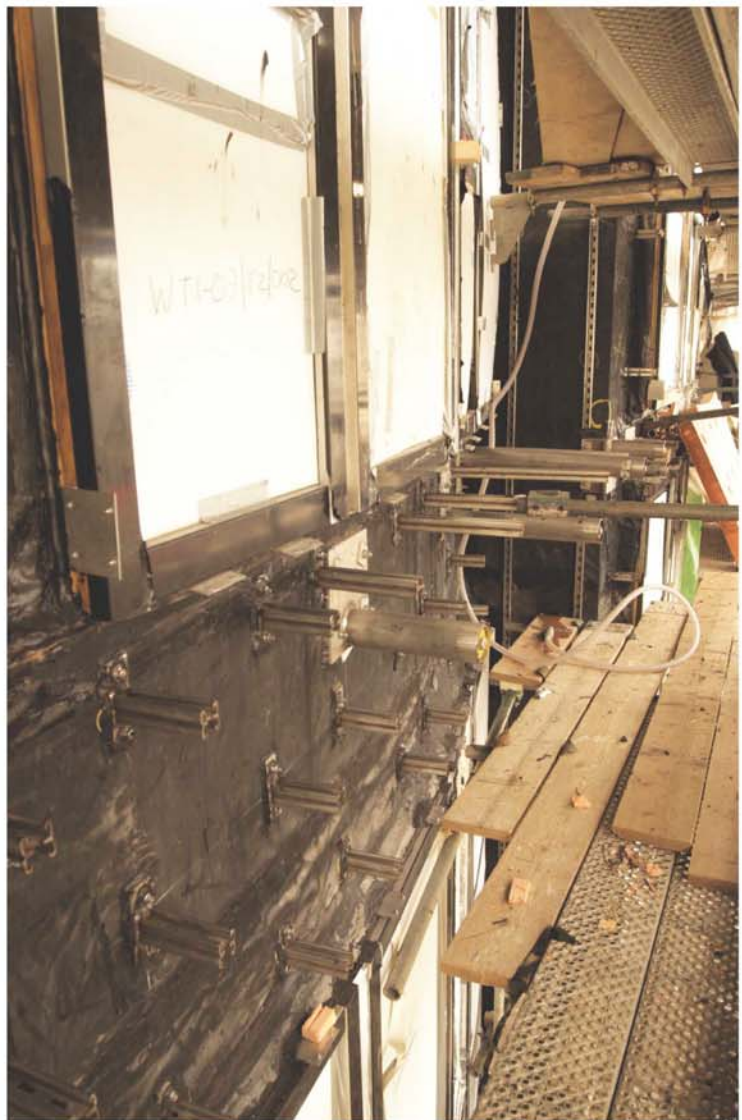
Approximately 75% of the window fixings to some 350 windows have been replaced with each fixing of a bespoke design due to the complexity of the structure's geometry and blast loadings. These challenges to window design were increased by the need to align the windows into the building so that they are flush with the surface.

Each of the above factors have resulted in the window installation being significantly more arduous than envisaged. The consequence is that the trade package contractor has been unable to achieve the output which previous construction programmes reflected.

*Blast Window Installation: problems with installation to meet blast proofing requirements mean that the installation rate has been cut from a projected 24 per week to 12 per week*

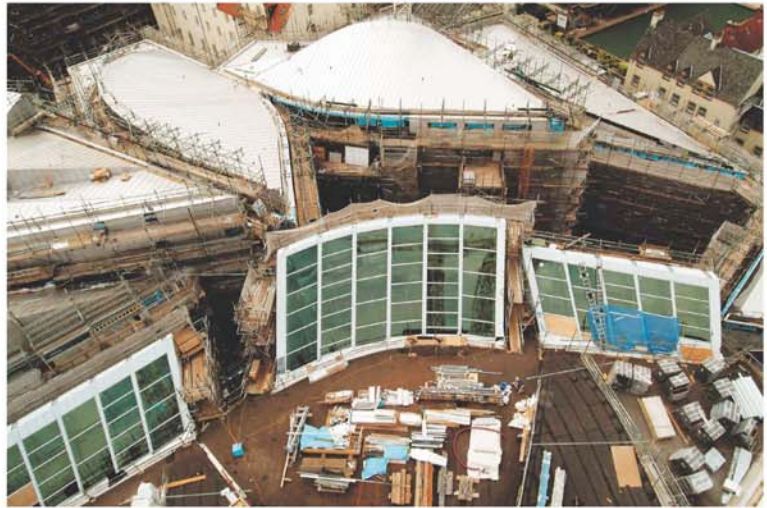
Construction in the north lightwell is further constrained by the logistics of the site which impose severe access restrictions — with the overhanging structure of the Towers (which range in height from three to seven stories) and the location of the link bridge preventing the use of tower cranes.

*Aerial view of lightwell highlighting access restrictions from adjacent structures.*

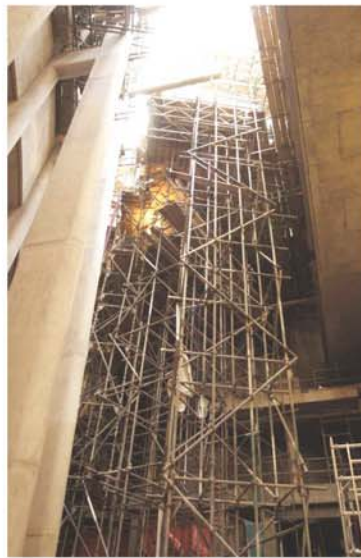
*Tower scaffolding preventing current access to lightwell.*

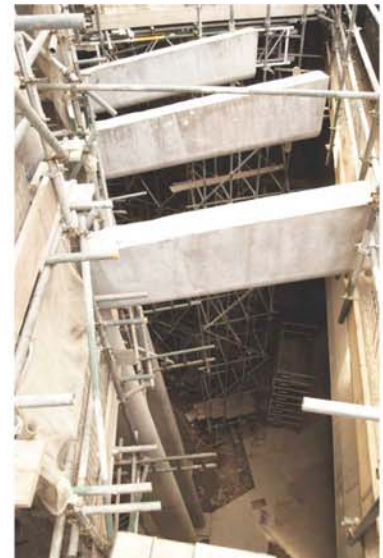
*View from link bridge depicting access restrictions into lightwell.*

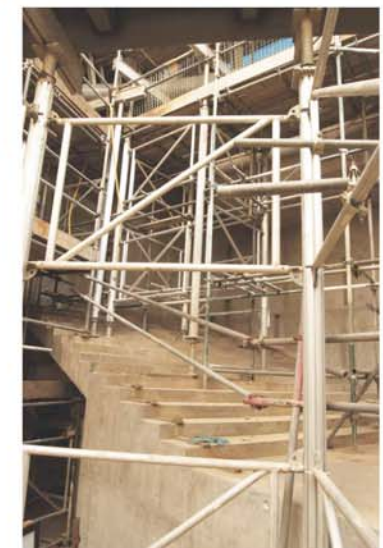
*Existing scaffolding preventing construction of public stair.*

As explained earlier, the construction of the public stair cannot commence until the scaffold from Towers 1, 2 and 3 has been removed from the lightwell.

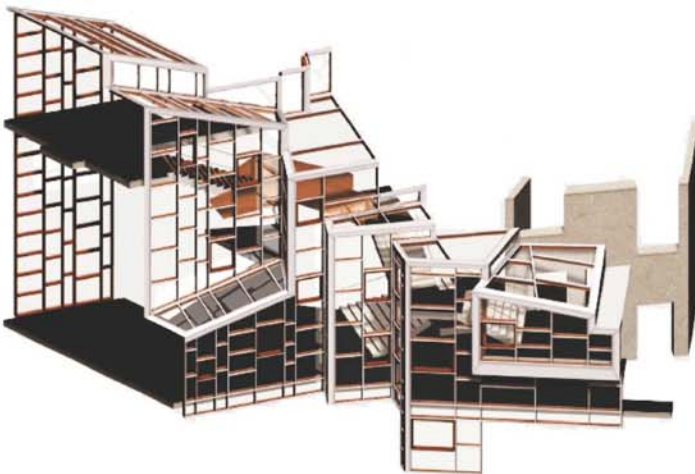
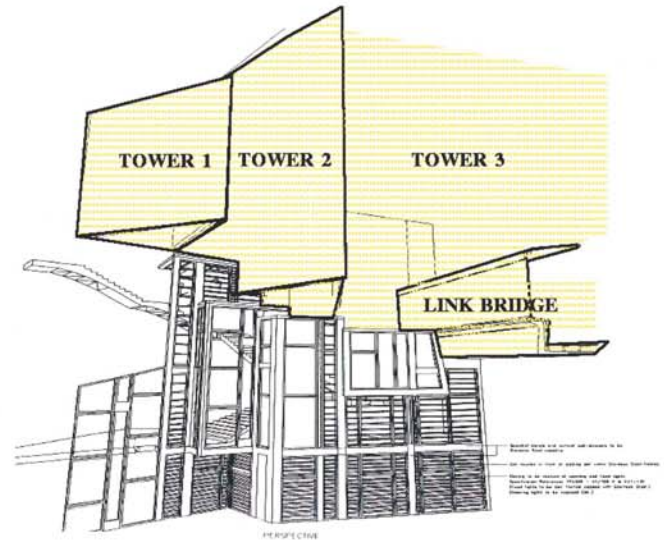
The public stair itself has a complex geometry which when coupled with the stair's location beneath the soffits of Towers 1 and 2 and its proximity to the oversailing link bridge means that access is restricted and it is not possible to use traditional cranes. This has added to the extended timetable for completion.

*The Public Stair: a highly complex structure that threads its way through buildings over three levels.*

*Sectional Diagram: Towers 1, 2 and 3 are situated above the link bridge and public stair. Beneath them are several hundred individual components of glass, steel, timber and pre-cast concrete which have still to be completed.*
